WATER LEAK - FRONT FLOOR AREA

TECHNICAL SERVICE BULLETIN

Reference Number(s): 08-26-7, Date of Issue: January 5, 2009

FORD: 2005-2009 Mustang

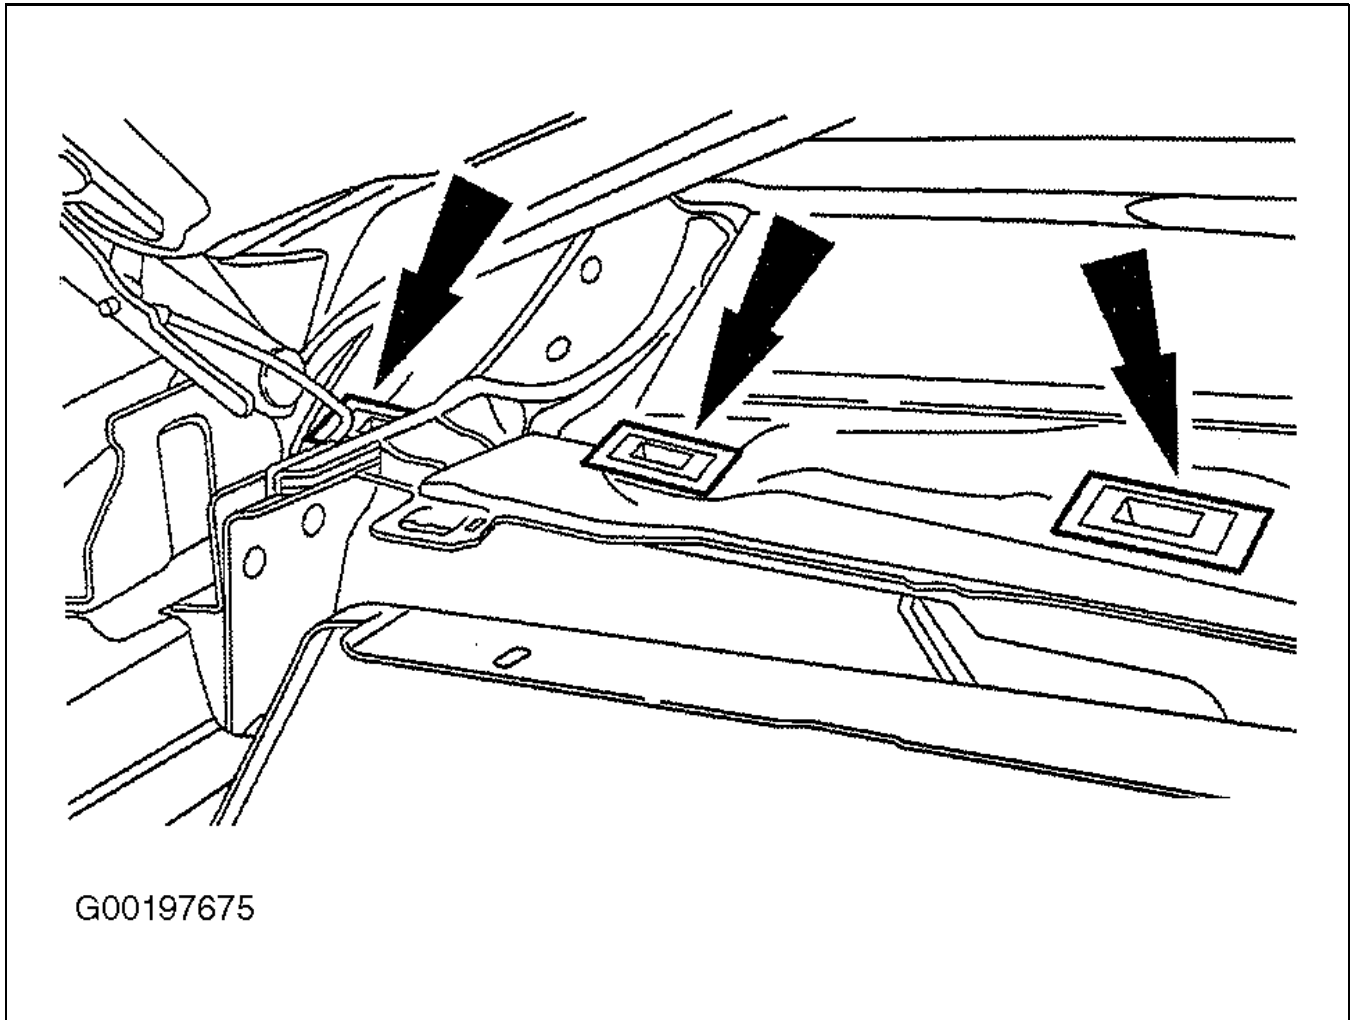
Fig 1: Cowl Panel Mount Grommets

1. Verify that the plastic cowl panel grill is evenly seated against the windshield and not warped. If warped, replace with current service stock.
2. Remove the cowl panel grill. Refer to Workshop Manual (WSM), Section 501-02, and inspect for proper cowl panel mount grommet installation and pinch weld sealing. Water may enter the cowl channel, through the cowl panel grommets / seals or forward pinch weld, potentially causing a sloshing sound and/or water leaking down the dash kick panel area. If there is standing water in the cowl channel, remove by siphoning through a cowl panel mount grommet hole. (Fig 7 -Fig 8 - end of article)
3. Verify that the ten (10) cowl panel mount grommets and seals are installed and sealing tightly to the vehicle. If any are missing, or the seals are damaged, replace as necessary. (Fig 1)

- a. Remove old cowl grommets and clean entire cowl surface with a suitable wax and grease remover. If silicone and/or seam sealer was used to seal grommets, ensure all sealer is removed before installing new grommets.
- b. With surface clean and prepped, snap the hot melt cowl grommet into cowl panel.
- c. Using a suitable heat gun, heat the hot melt cowl grommet until the hot melt material begins to squeeze out from under the plastic grommet. Do not over heat the grommet because deformation of the plastic grommet may occur.
- d. After heating the grommets, a light amount of pressure may be applied to the outer perimeter of the grommet to help sealing.
- e. Do not over heat around windshield or fender edges or damage may result.

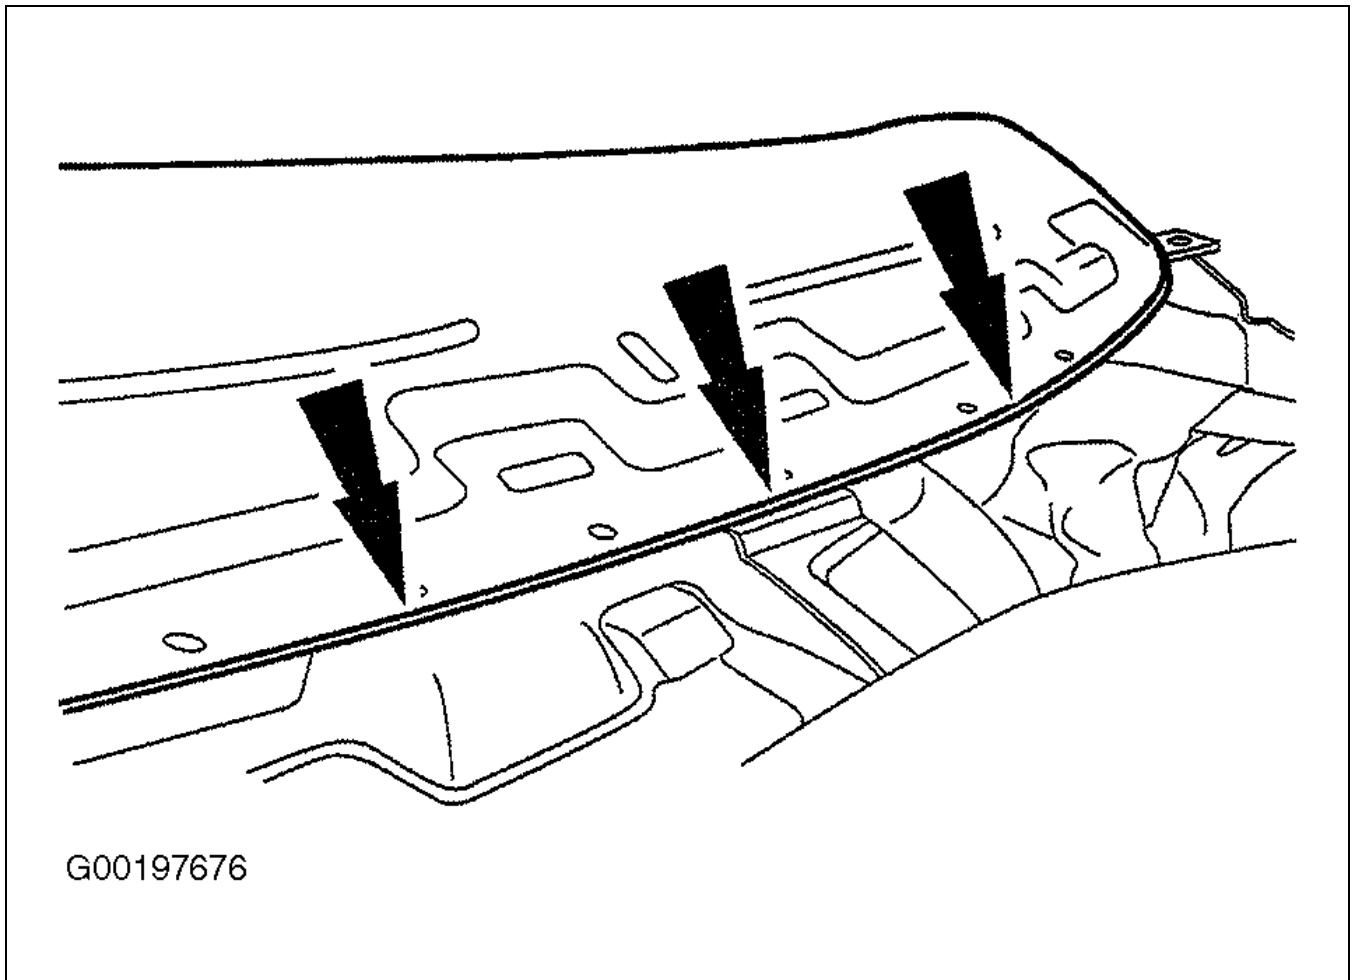
Fig 2: Cowl Panel To Bulk Head Pinch Weld

4. Inspect the cowl panel to bulk head pinch weld and A-Post to cowl joint for any skips in seam sealer or excessive gaps between panels.
 - a. To ensure a water tight seal, apply a small amount of Motorcraft Seam Sealer to the pinch weld and work into seam with fingertip, leaving a small amount on the edge, especially near the windshield center bracket area. (Fig 2)

NOTE: DO NOT USE SILICONE.

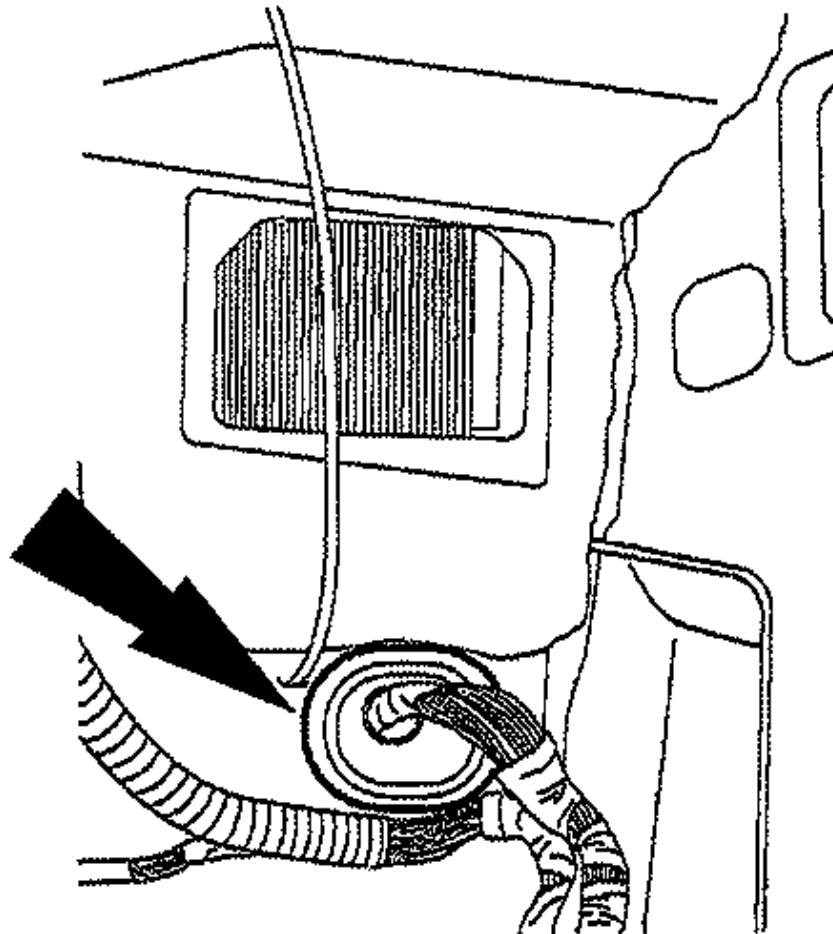
Fig 3: Main Body Wiring Harness Grommet

5. Check the main body wiring harness grommet for proper seating into the bulkhead on the driver / passenger side.

- a. Position the grommet into the bulkhead making sure the grommet is fully seated and sealed. If there is any aftermarket wiring installed through the grommet, reroute and seal as necessary. To ensure proper sealing , around the wiring harness grommet, apply a small amount of Motorcraft Seam Sealer and install the grommet. (Fig 3)

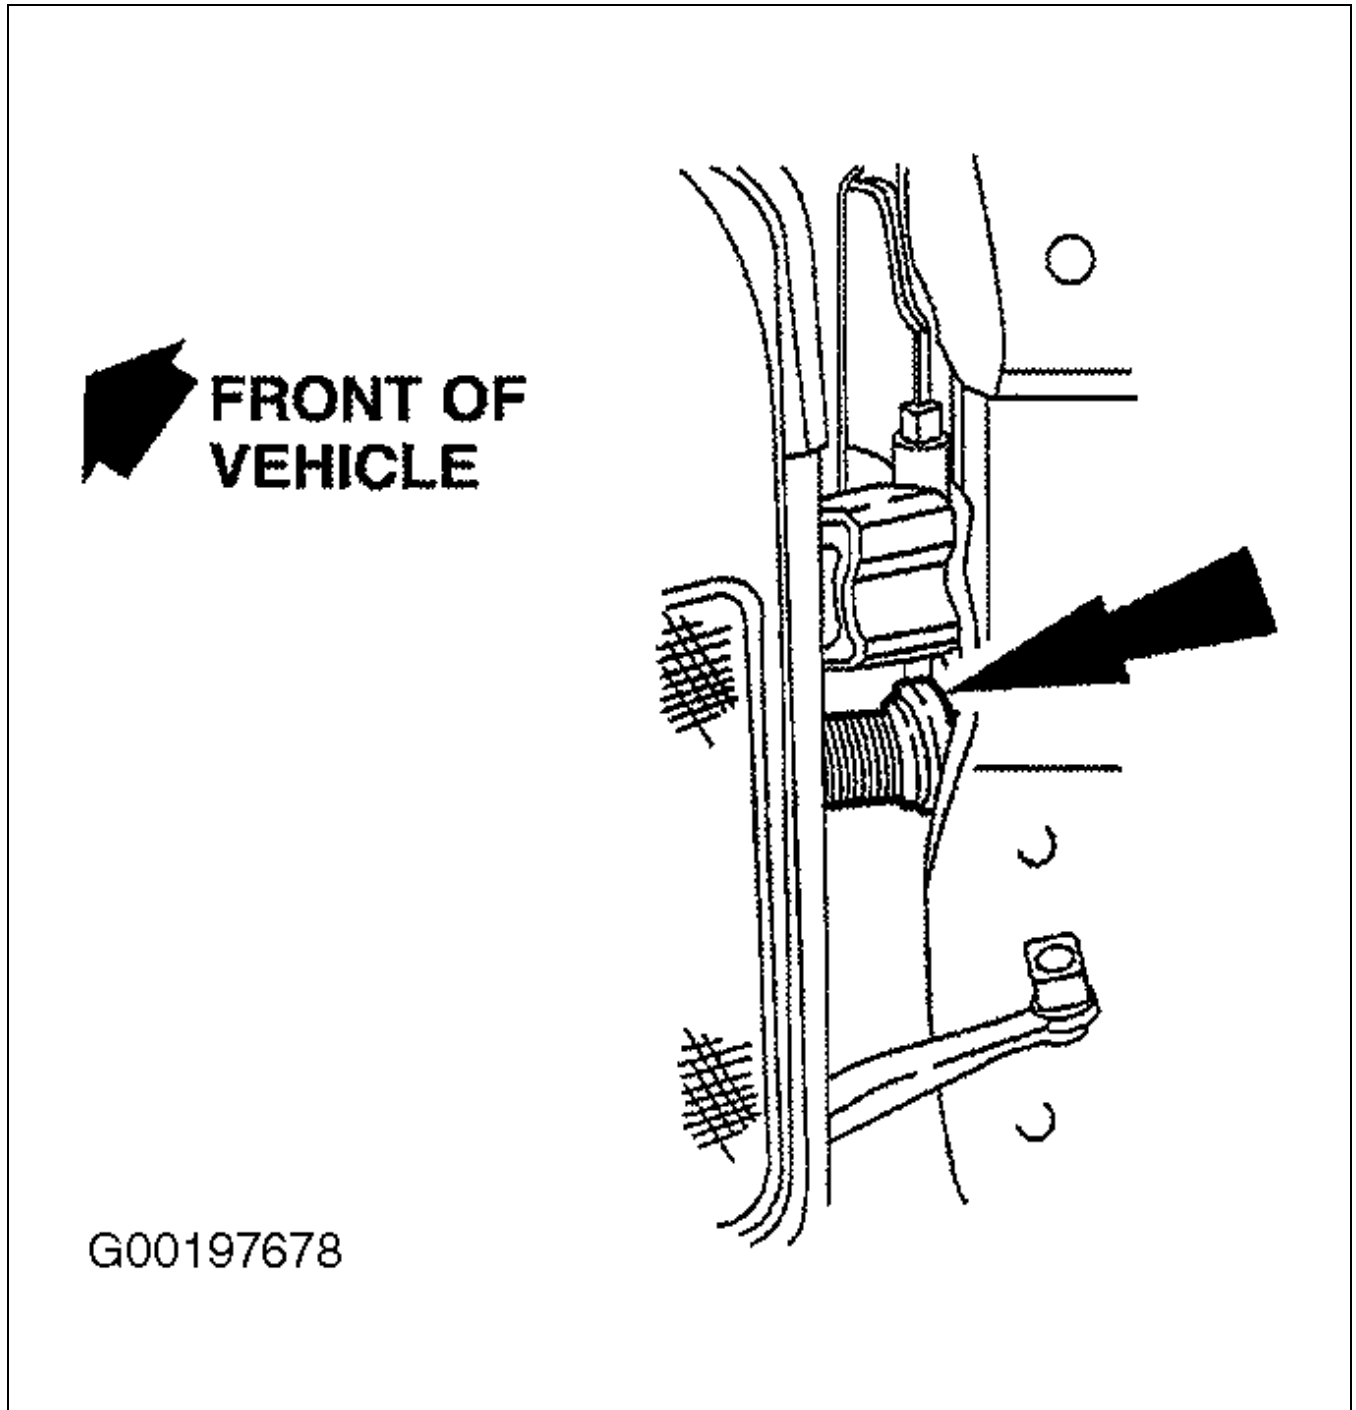
Fig 4: Door To A-Pillar Wiring Harness Grommet

6. Verify that the door to the A-pillar wiring harness grommet is fully seated into the A-pillar.
 - a. To ensure proper sealing around the wiring harness grommet, apply a small amount of Motorcraft

Seam Sealer and install the grommet into the A-pillar. (Fig 4)

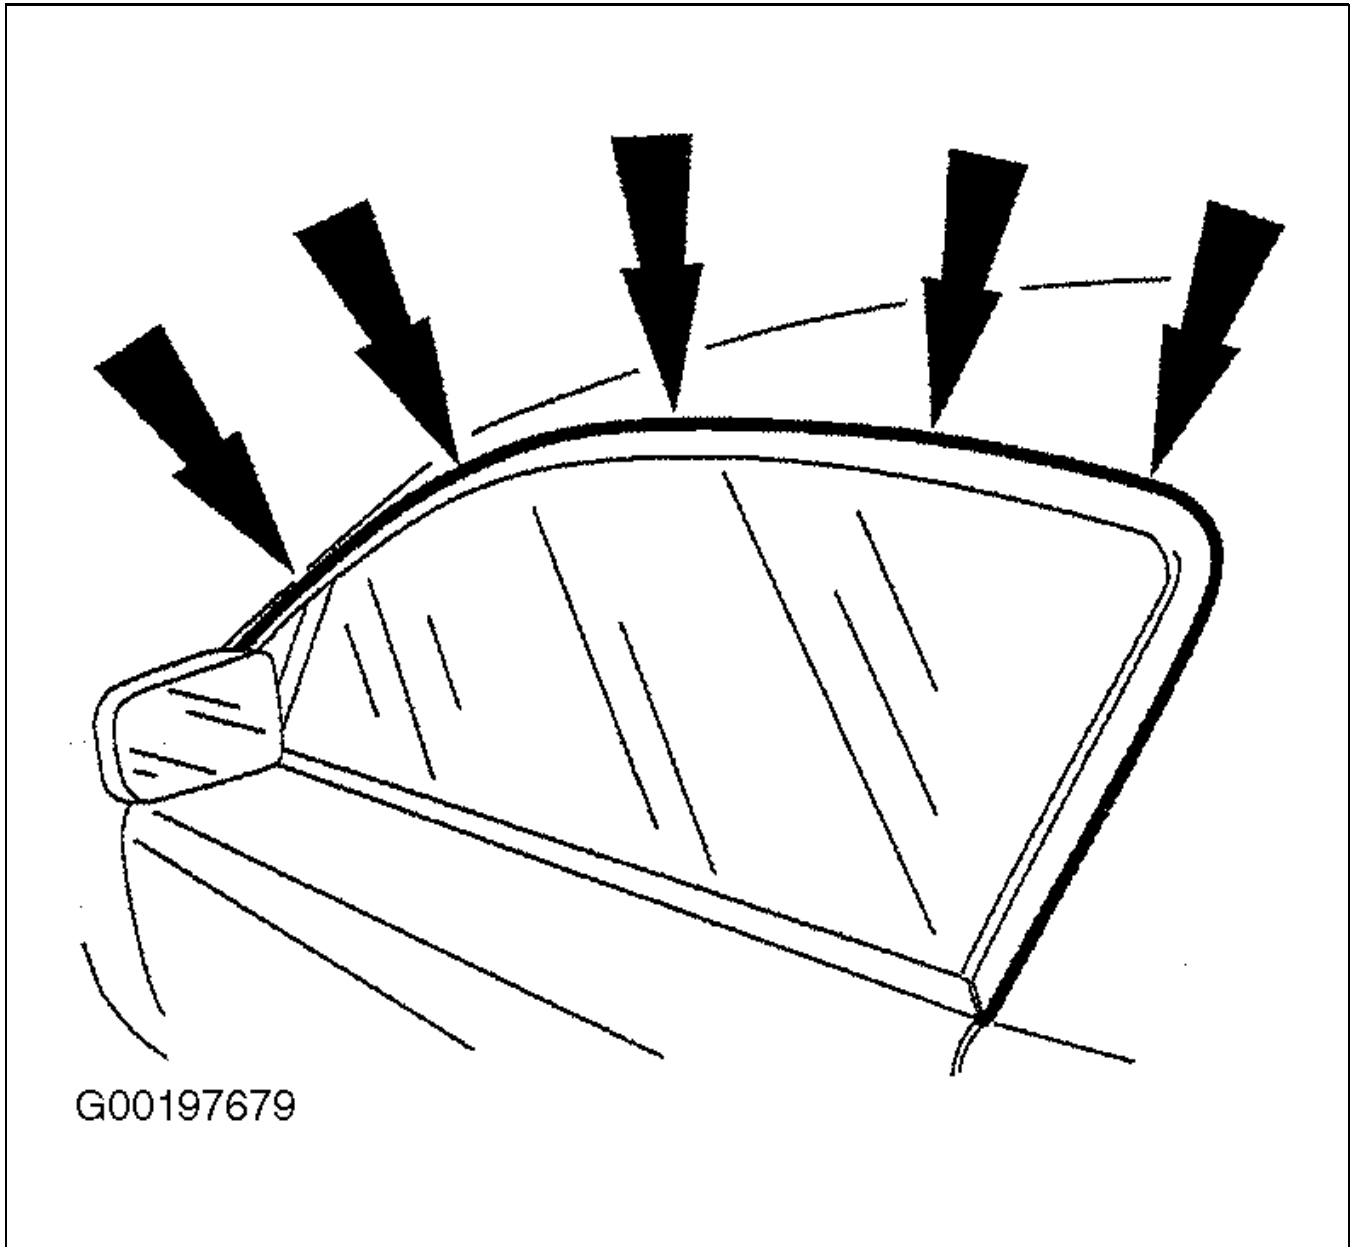
Fig 5: Window Weatherstrip

7. Remove and inspect the foam seal of window weatherstrip retainer at the A-pillar. Tears in the foam seal may allow water to enter the vehicle, between window weatherstrip retainer and the A-Pillar, and travel inside the interior A-Pillar trim molding into the dash kick panel area. (Fig 5)

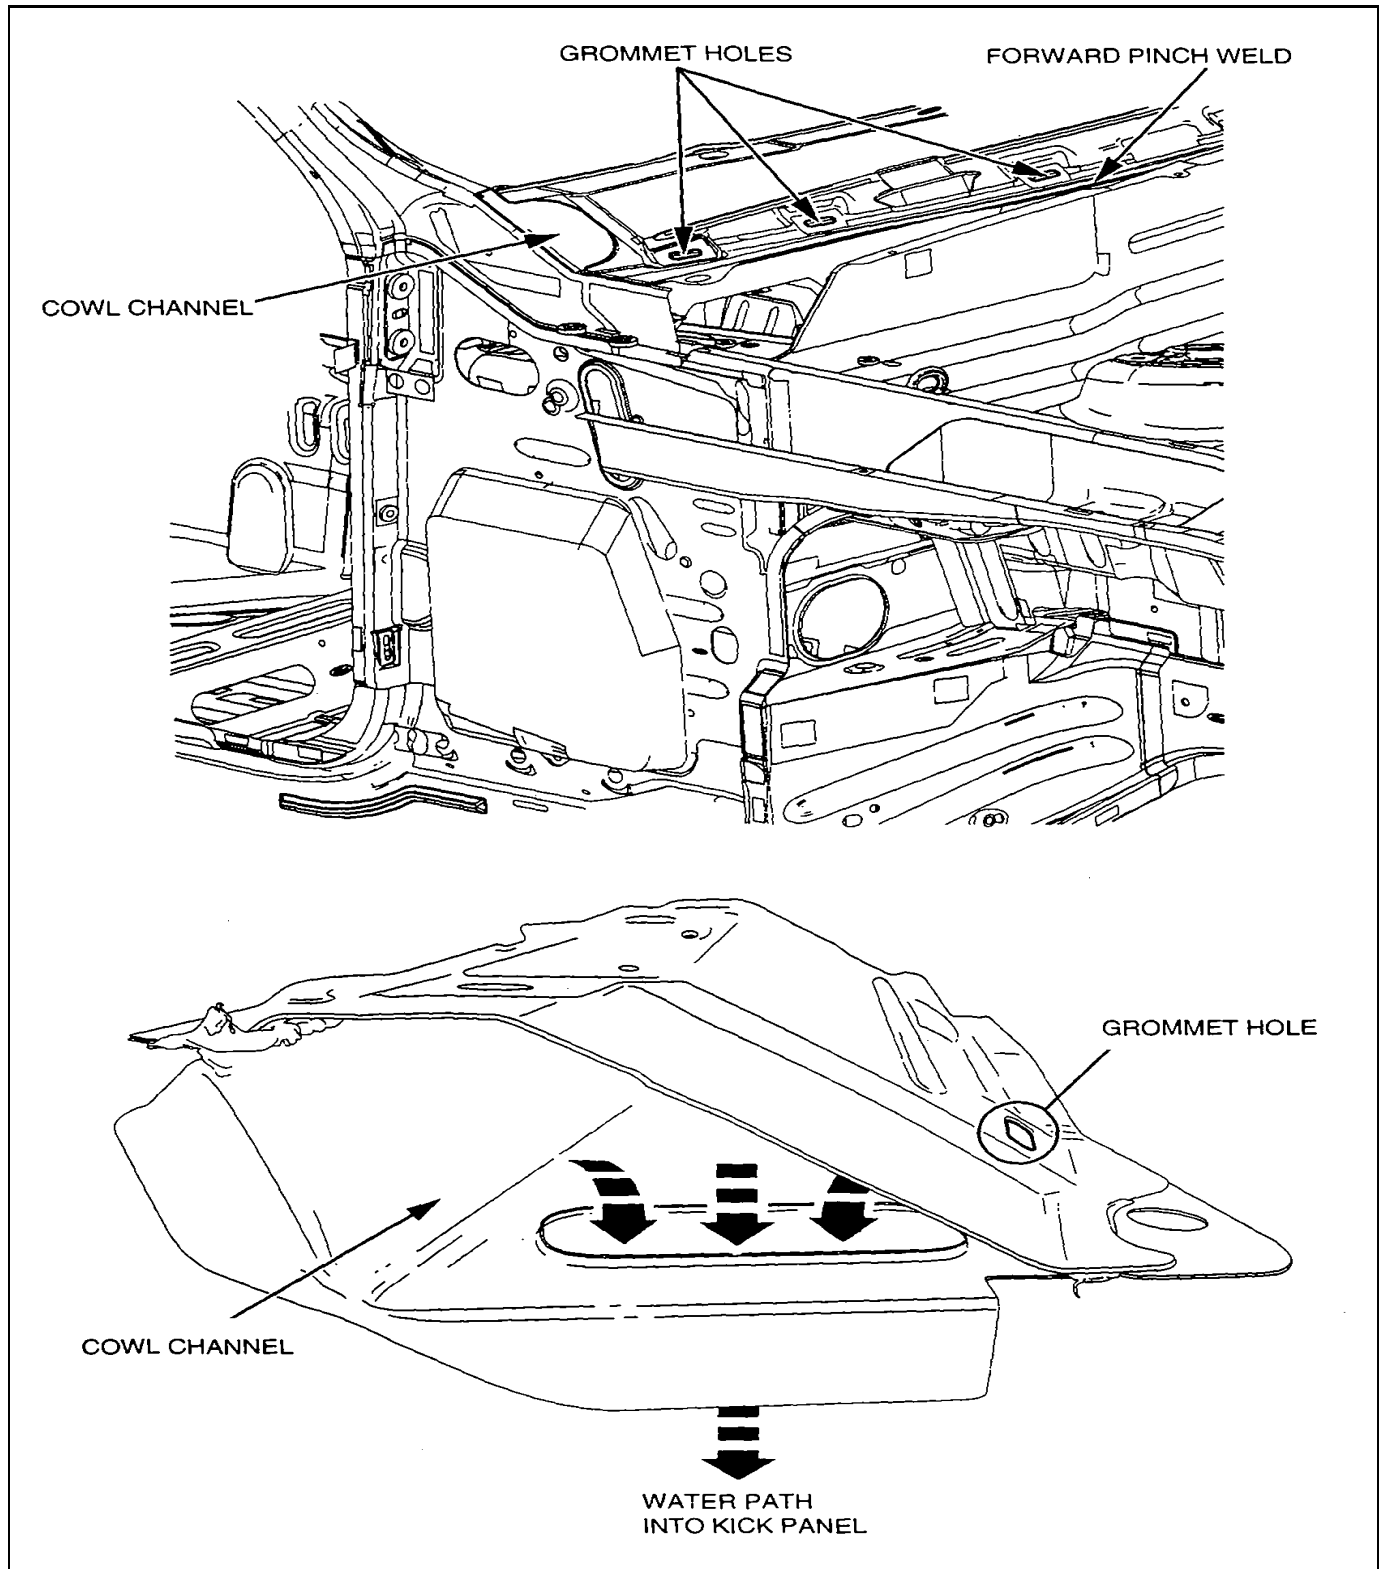
Fig 7: Cowl Grommet Locations

NOTE: DO NOT REMOVE COWL GROMMETS DURING WATER TESTING. (Fig 7 AT END OF ARTICLE)

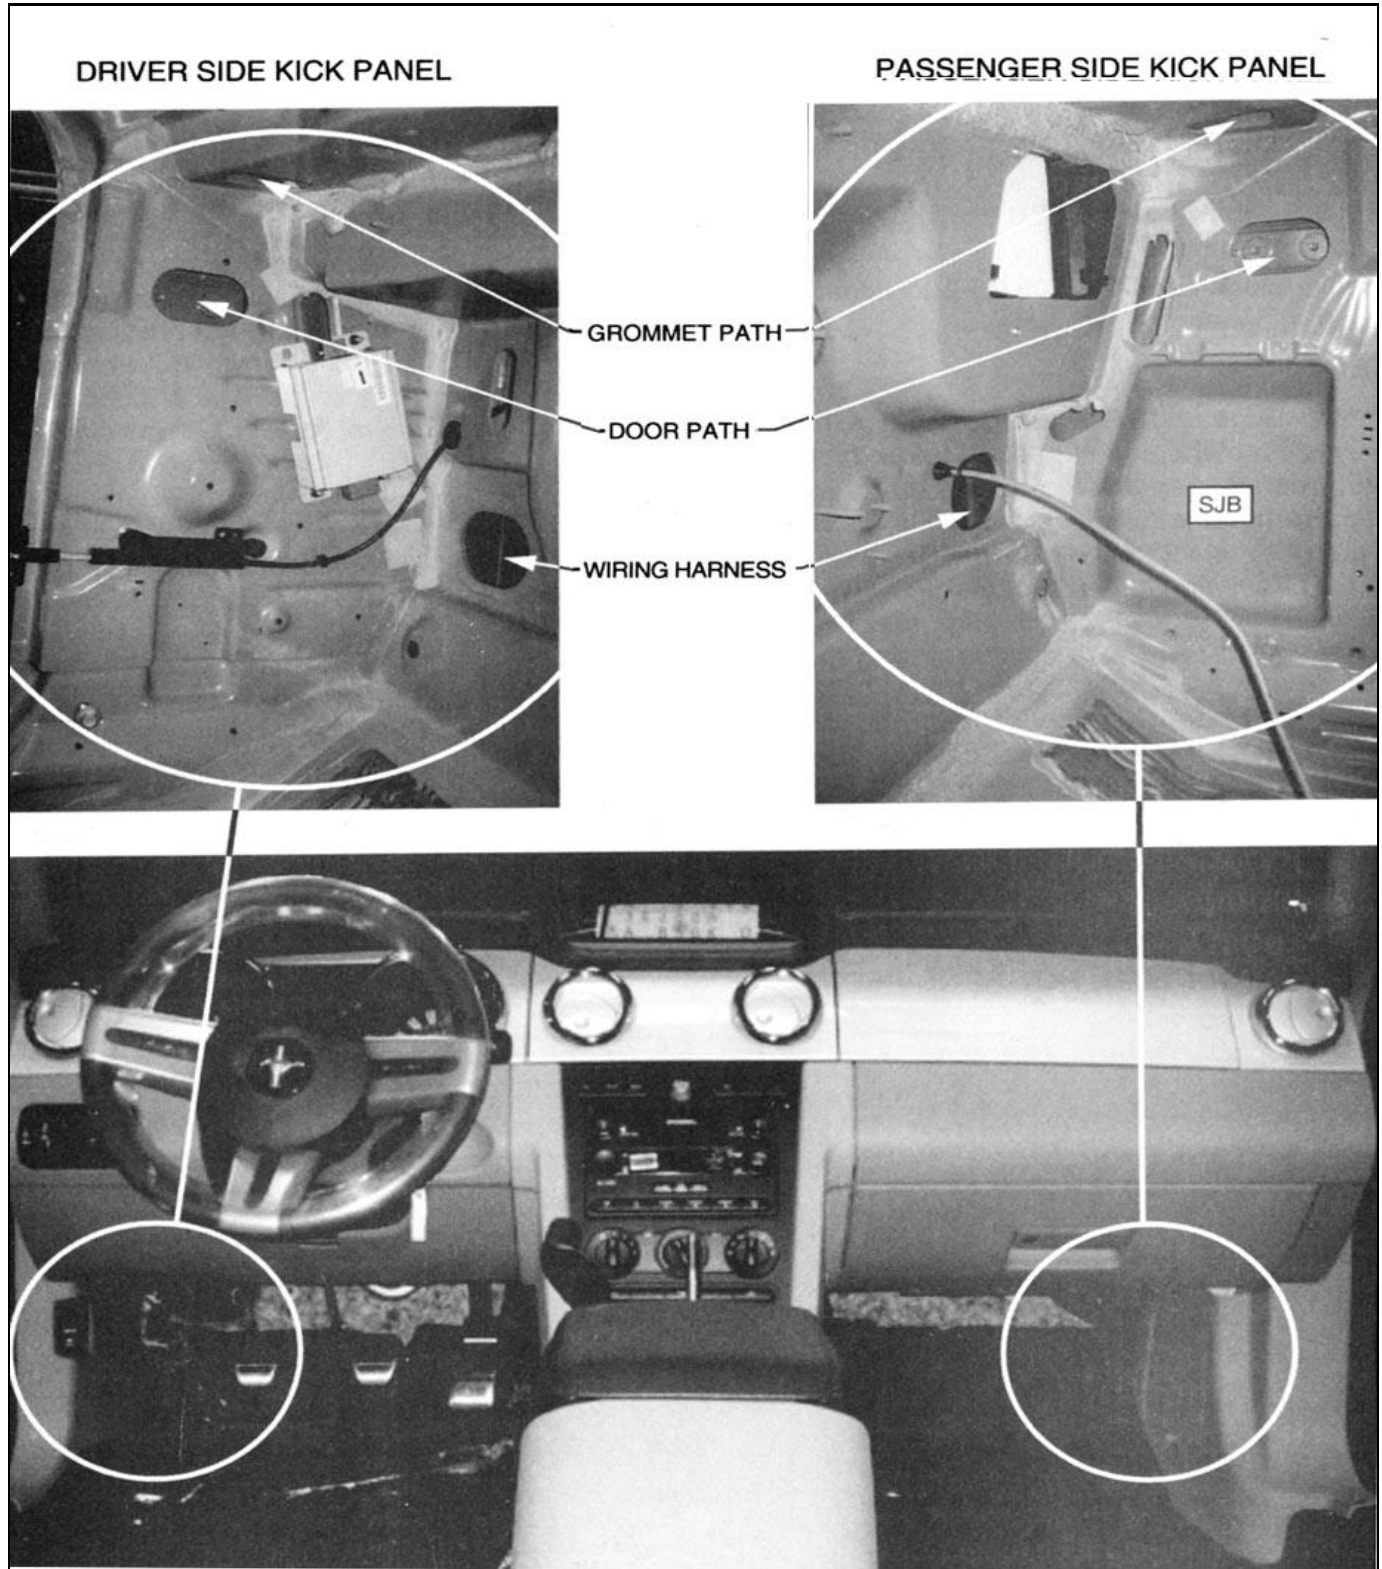
Fig 8: Water Paths Into Front Kick Panel Areas

Some 2005-2009 Mustang vehicles may exhibit a difficult to diagnose water leak in the front floor area. This may be caused by loose grommets and/or sealer skips around the cowl area, loose A-pillar window weatherstrip retainer, misaligned body harness grommet through the firewall, misaligned body harness grommet from the passenger door.
